WATER QUALITY MONITORING AGREEMENT

WATER QUALITY ASSESSMENT OF MYERS CREEK AT THE INTERNATIONAL BOUNDARY (1998 – 2002)

Pommen Water Quality Consulting

November 2003

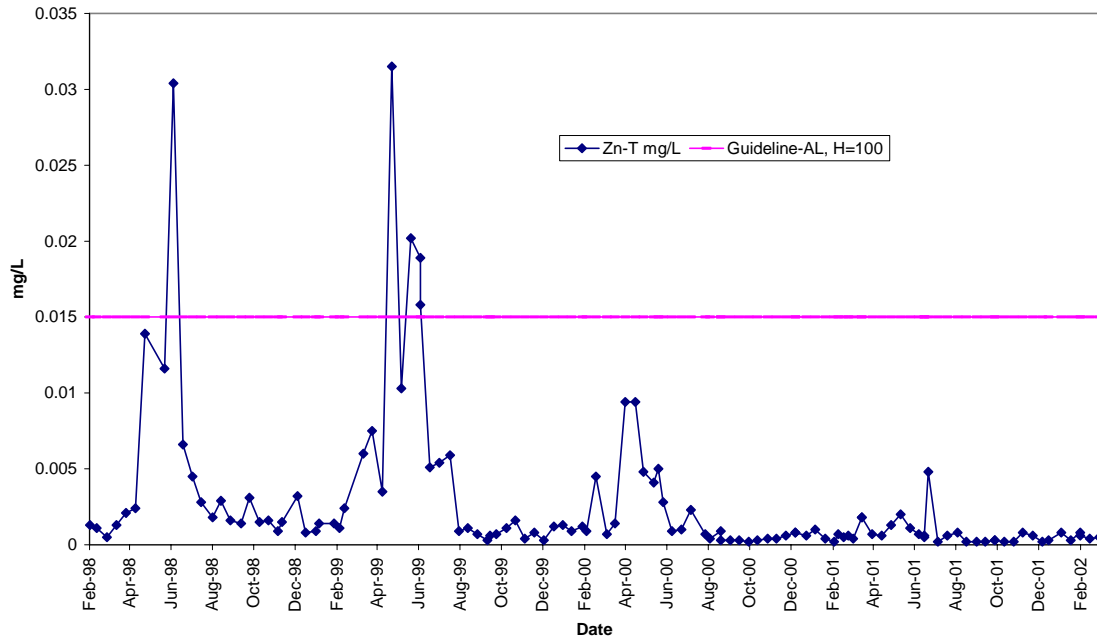
Figure 65 Zinc, Extractable

Zinc, extractable and total (Figures 65 and 66) were quite similar, with peak levels during spring freshet when turbidity was high. When the hardness of the individual values is considered, one extractable zinc and three total zinc values exceeded the aquatic life guideline during the spring freshet of 1999, when turbidity was high (64-190 NTU). There were apparent declining trends in both forms of zinc due to the declining trend in turbidity.
